November 4, 2022

Re: 2634, 2636, 2640, 2642, and 2654 Eglinton Avenue West & 1856 and 1856A Keele Street (Ward 5)

Arborist Report

c/o Paul Li M.Env.Sc
Curtis Ha ON-2864A
Central Tree Care Ltd.

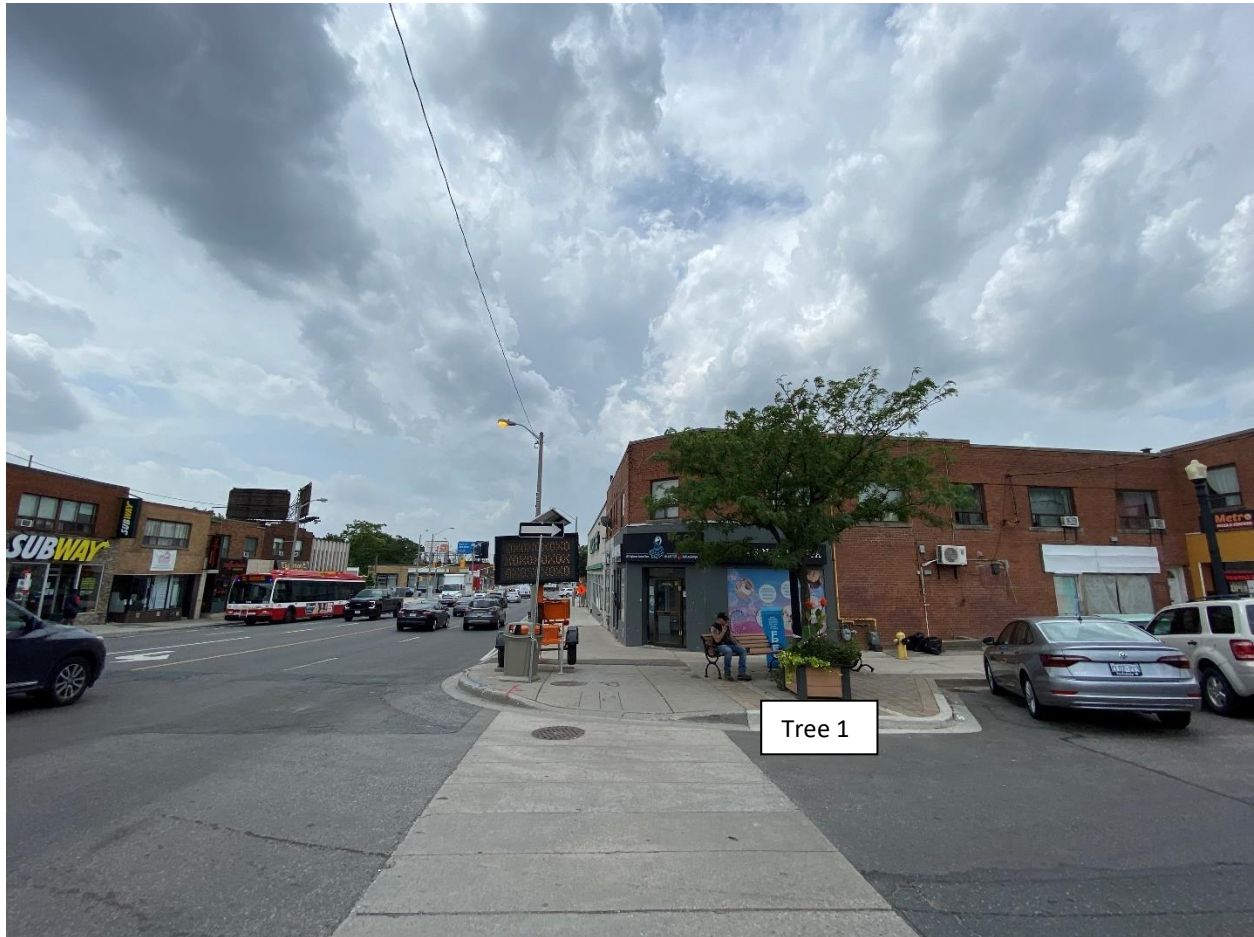
Figure 1. Tree 1 located in front of the subject property (facing west).

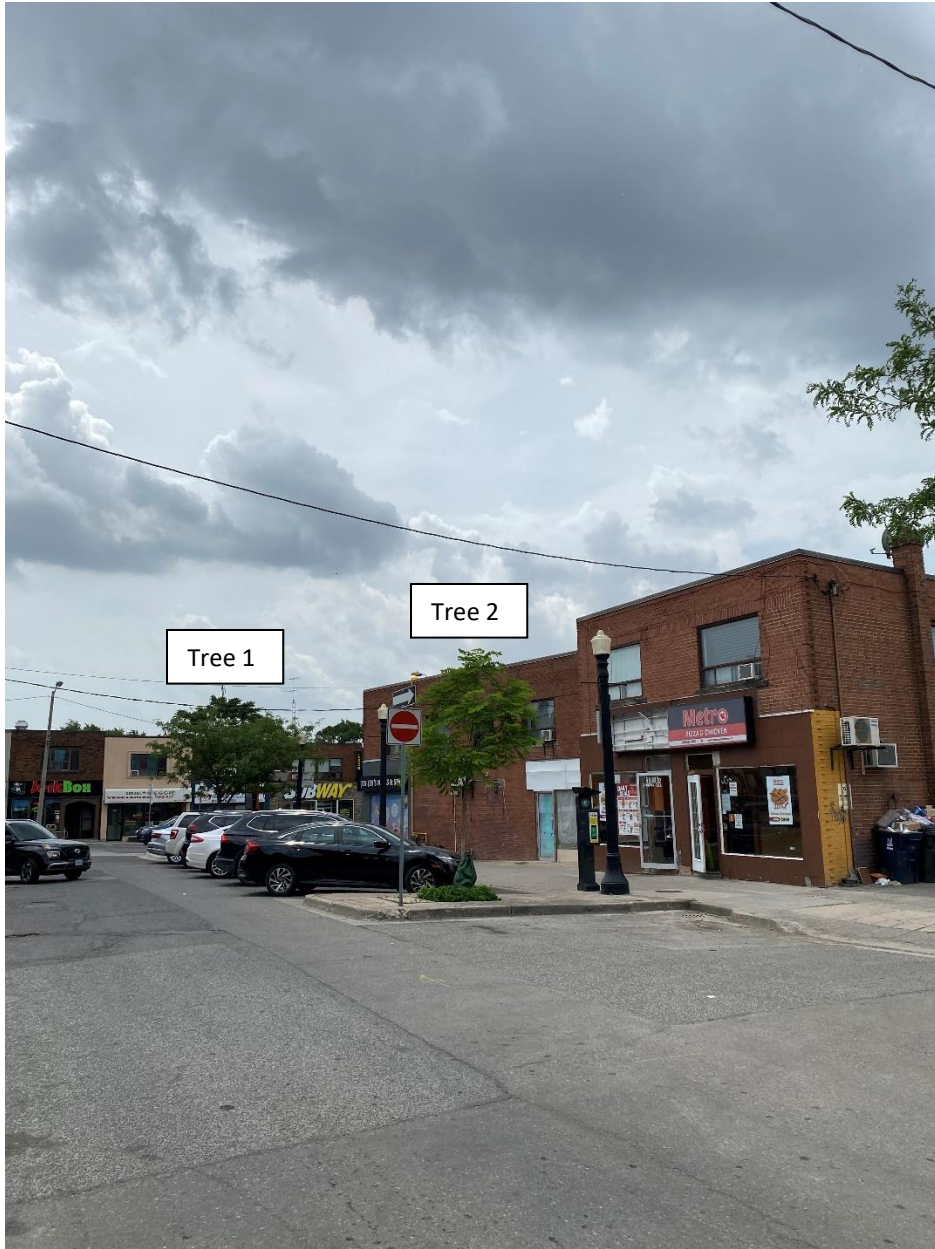
Tree 2 (6cm DBH Kentucky Coffeetree) is also located in close proximity to the site entrance however, due to the hardscape surrounding the base of the tree, vertical tree protection hoarding can only be installed directly surrounding the planting it, with the surrounding hardscape to remain in place acting as horizontal tree protection hoarding.

Figure 2. Trees 1 and 2 situated adjacent to subject property (facing south).

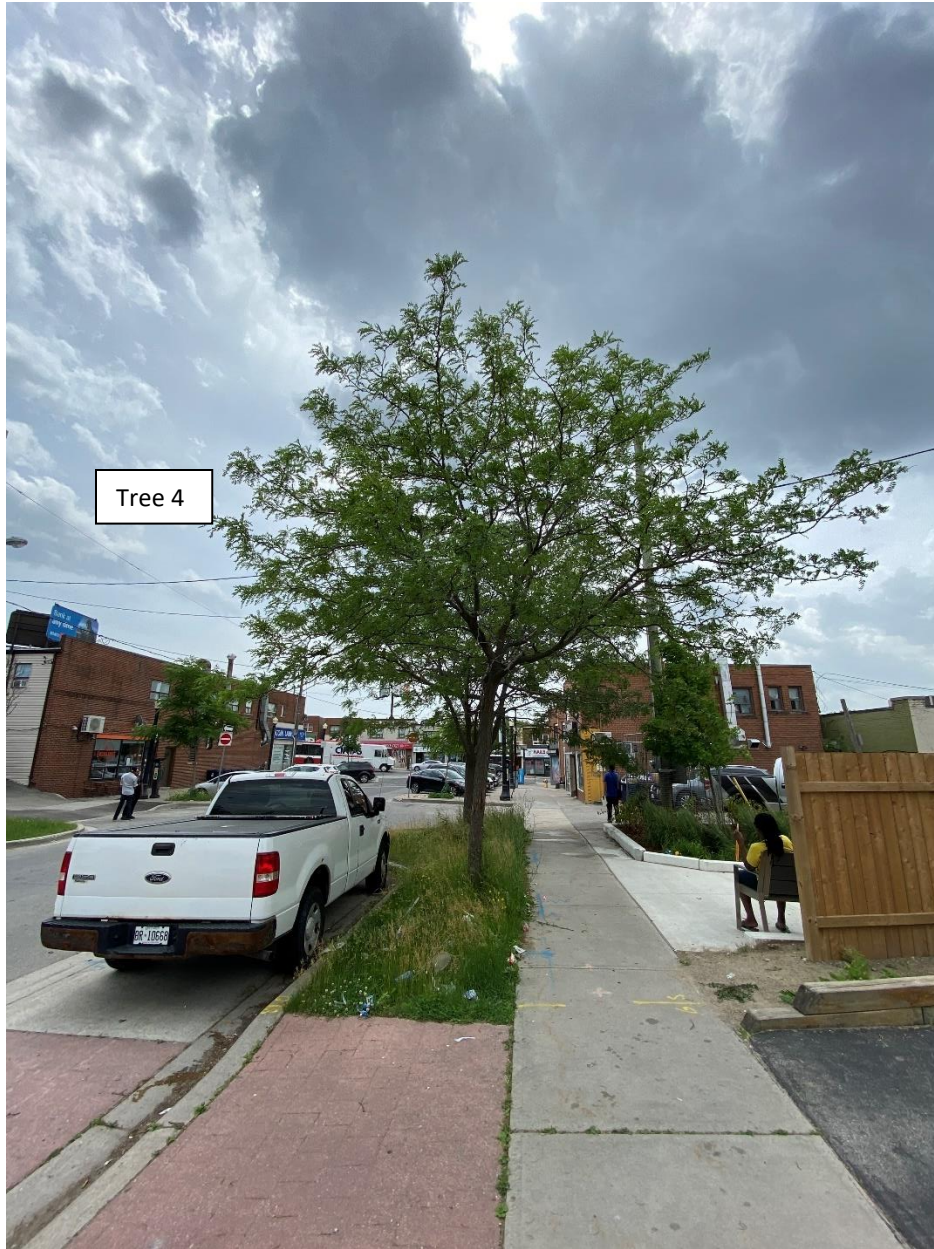
Figure 4. Tree 4 (facing south)

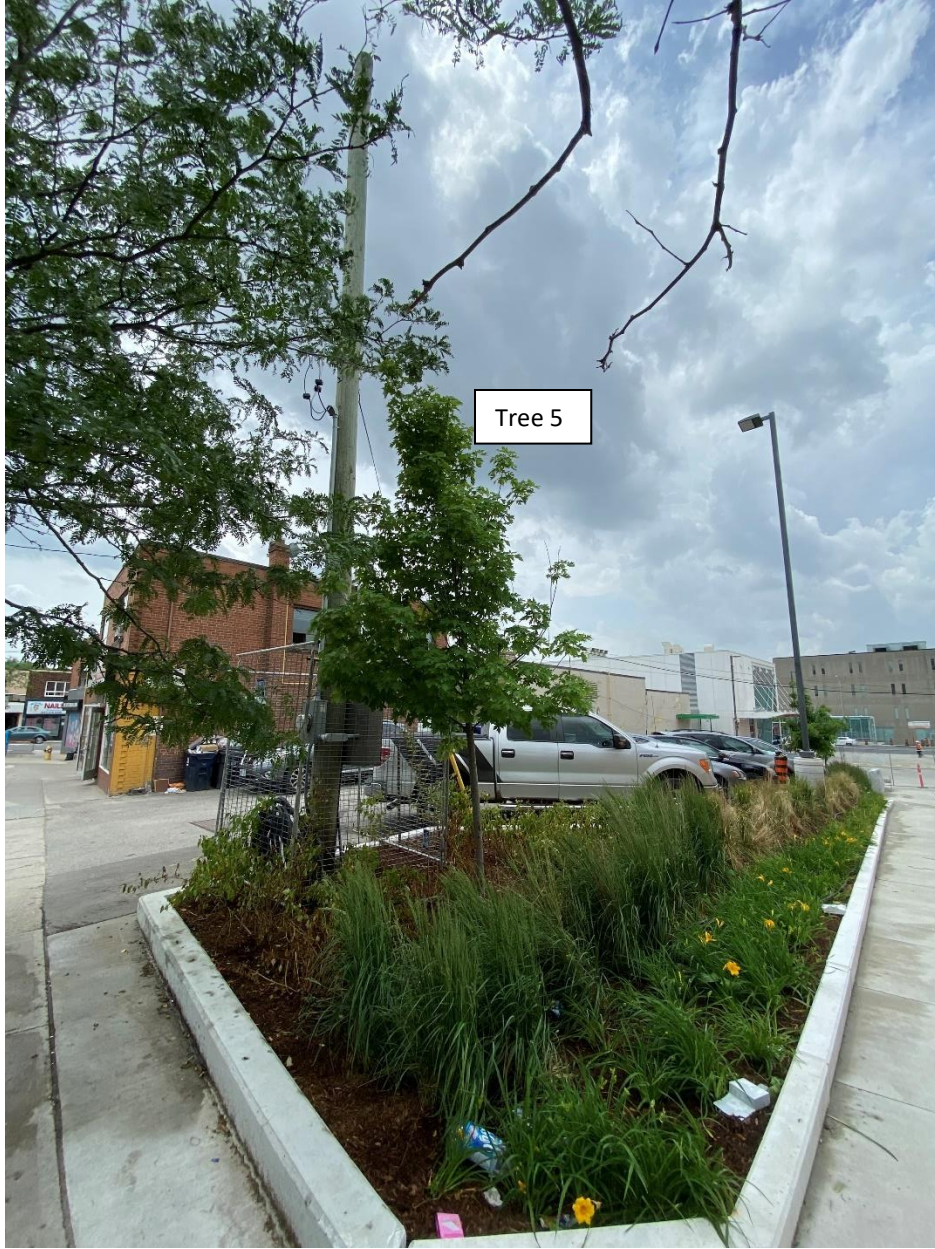
Figure 5. Tree 5 located on 1858 Keele St (facing southwest).

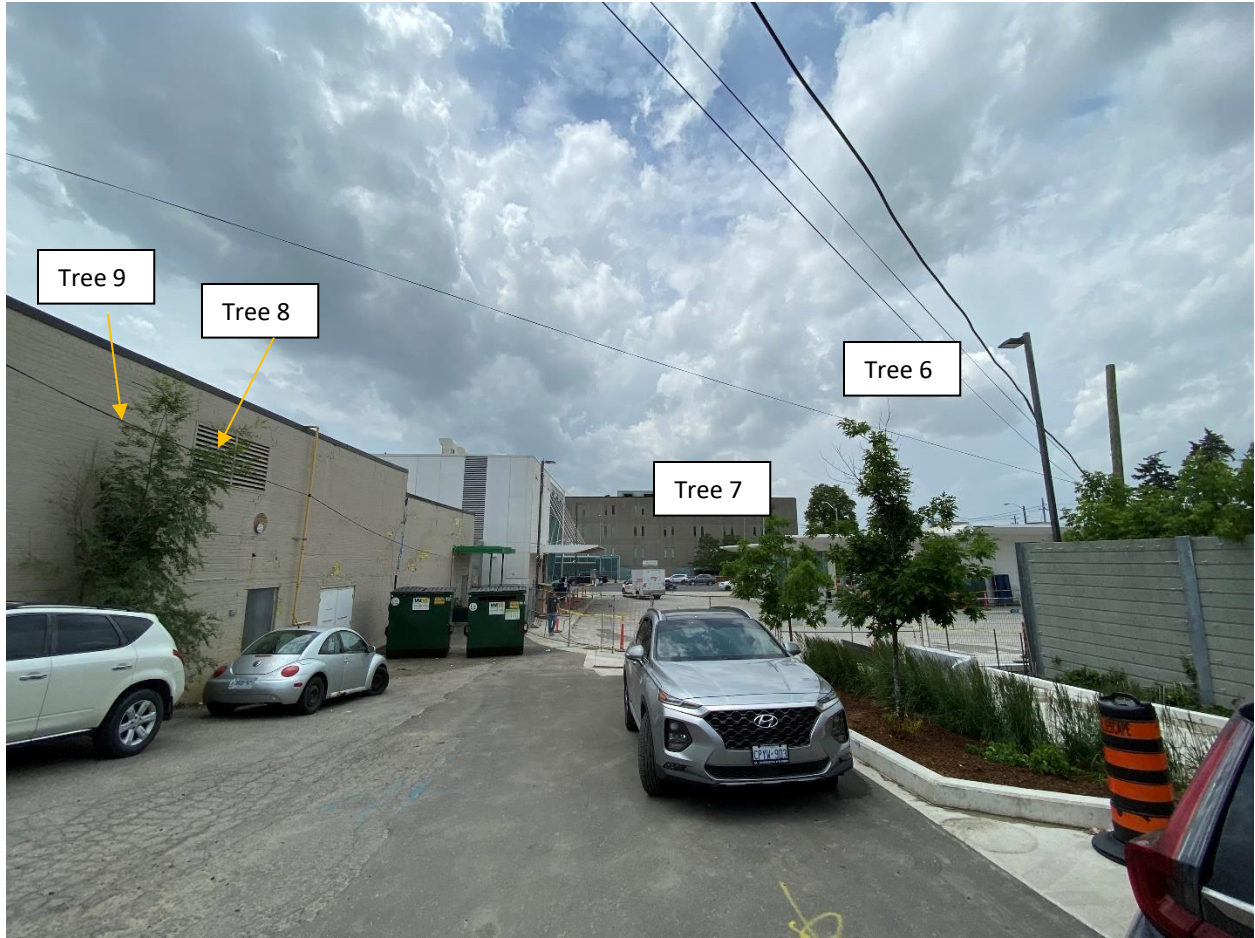
Figure 6. Trees 6 – 9 (facing west).

Additionally, though trees 6 and 7 are unregulated under TPPR, it is recommended that tree protection hoarding as proposed on the TPP is installed to fully protect the trees TPZs during construction if their retention is desired. Contrary, Tree 1 is a city-owned tree that is protected under the City of Toronto Urban Forestry by-law. However, due to the insufficient softscape surrounding Tree 1, hoardings cannot be adequately installed.

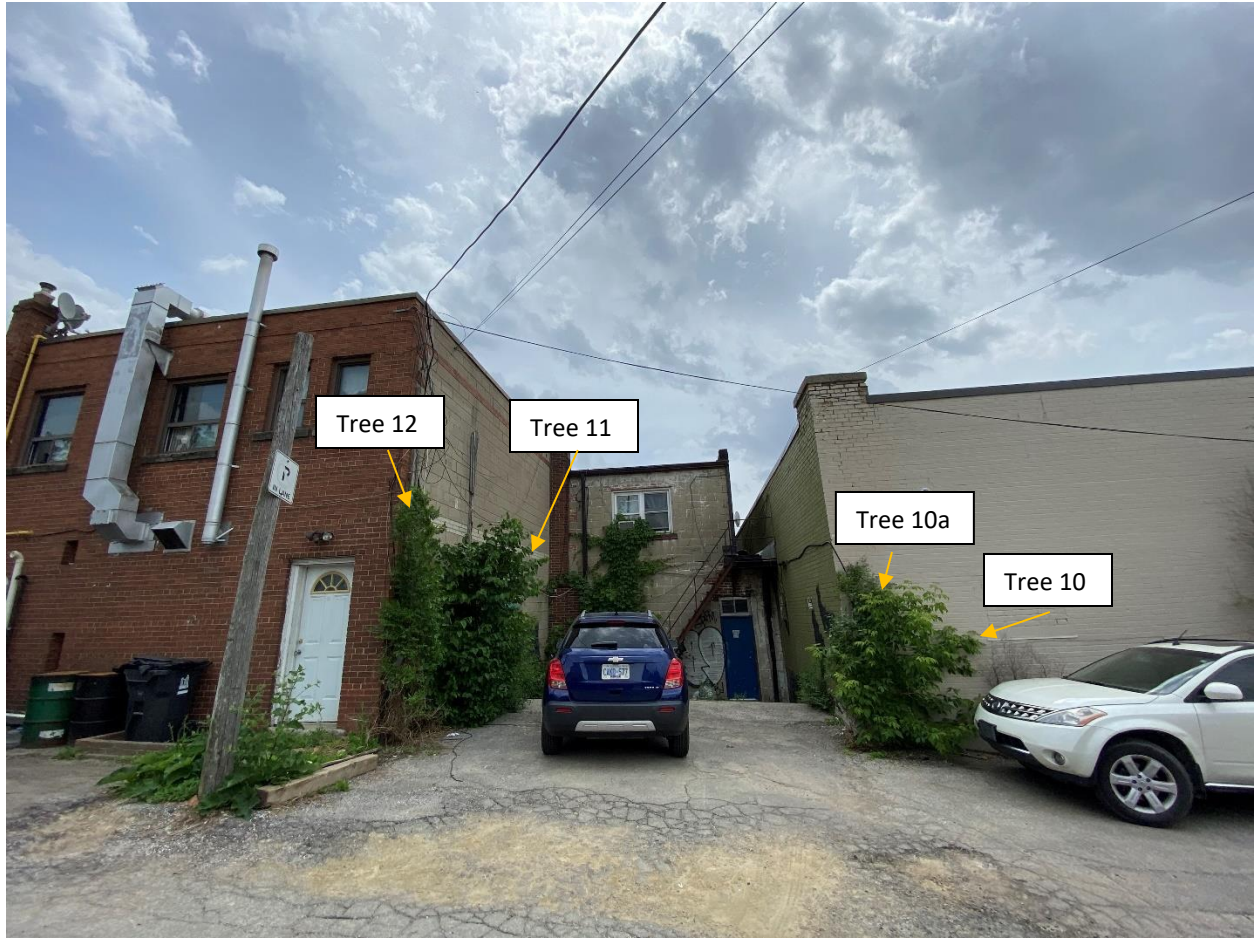
Figure 7. Trees 10 – 12 (Facing south).

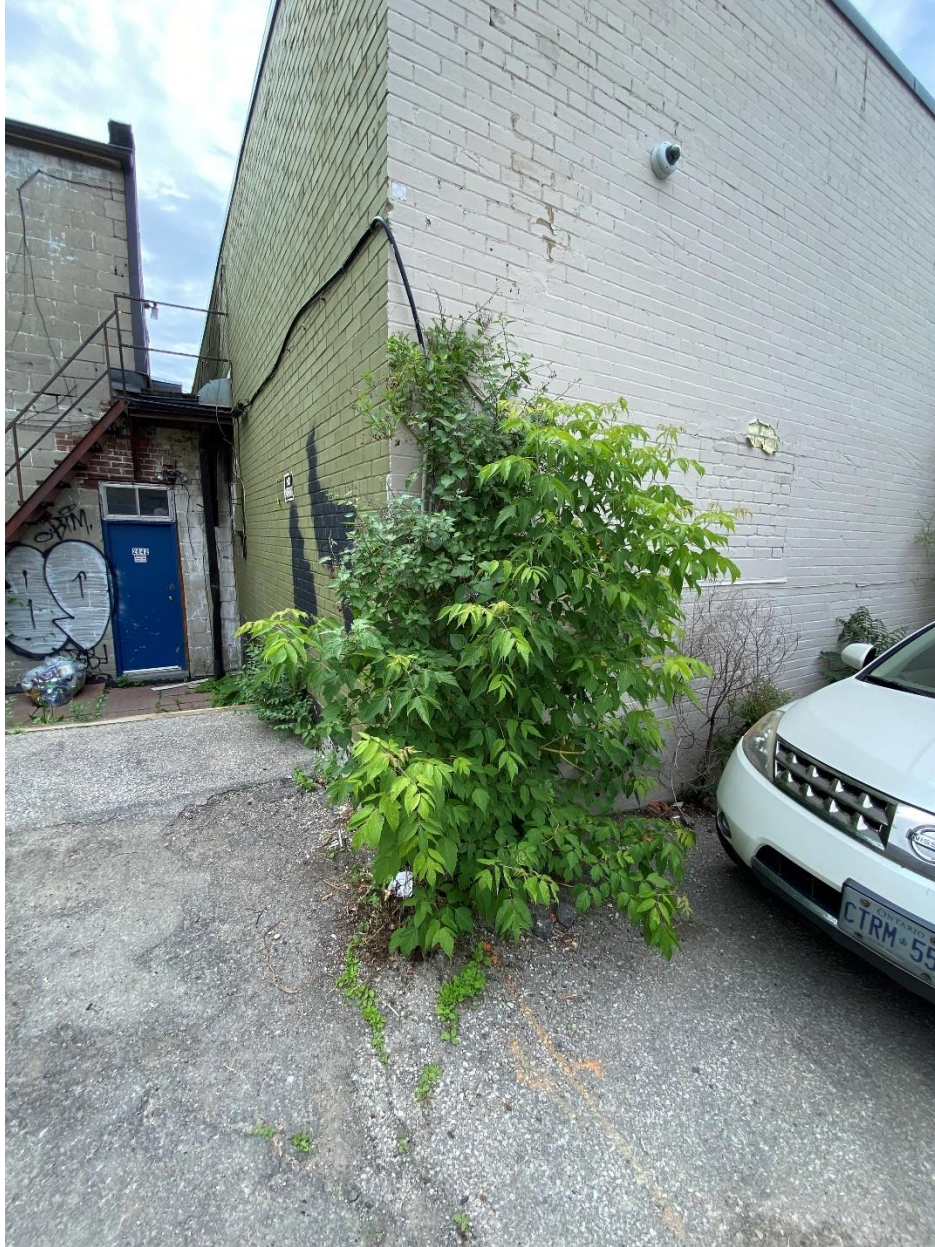
Figure 8. tree 10 (facing southwest).

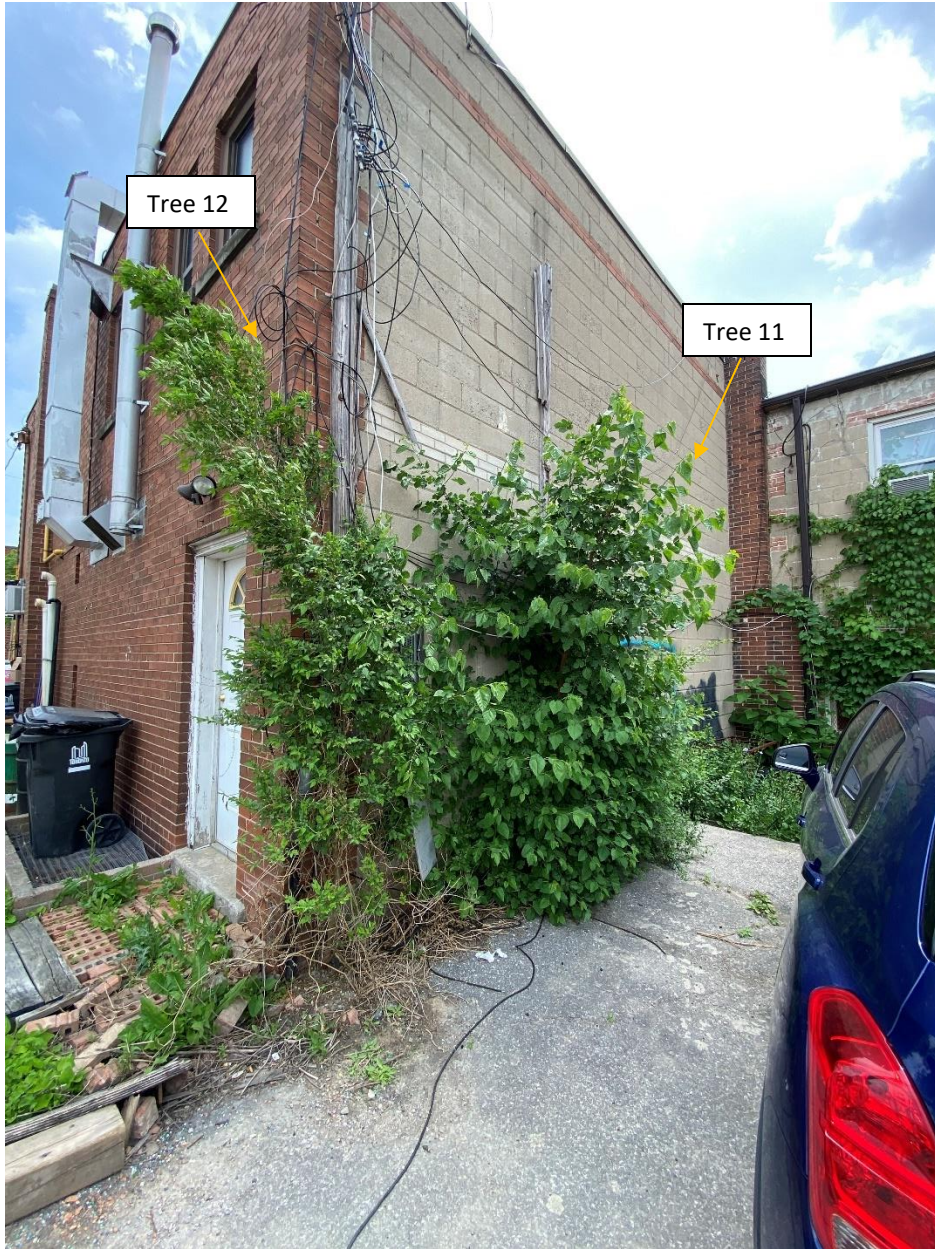
12	European buckthorn	<i>Rhamnus cathartica</i>	~3	1.2	Good	Fair	Growing from crack in asphalt, growing close to building. Overall healthy. Naturally seeded. Nightshade vine growing around stem and canopy.	Unregulated under TPPR	\

Figure 9. Tree 11 and 12 (facing southeast).

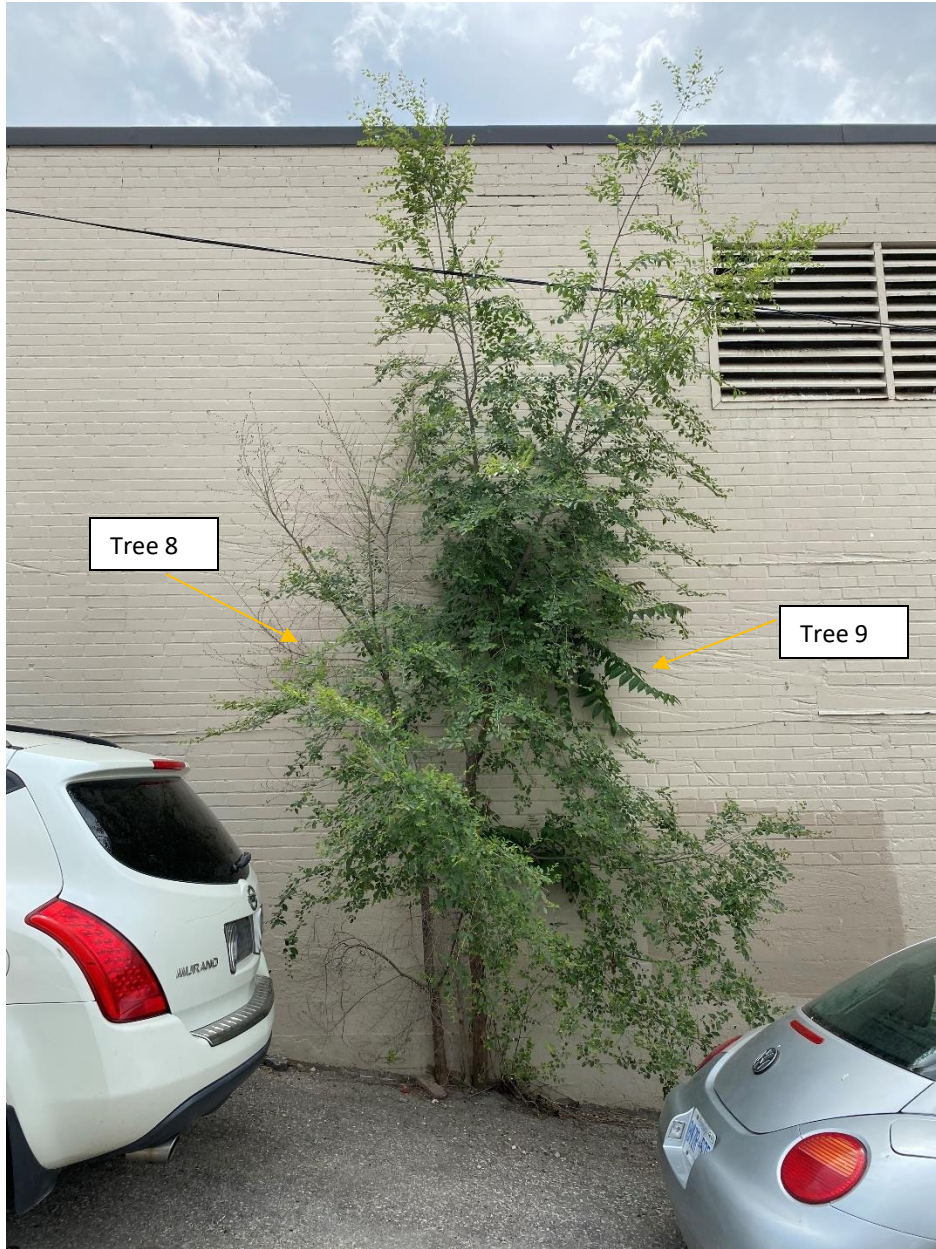
Figure 10. Tree 8 and 9 (facing south).

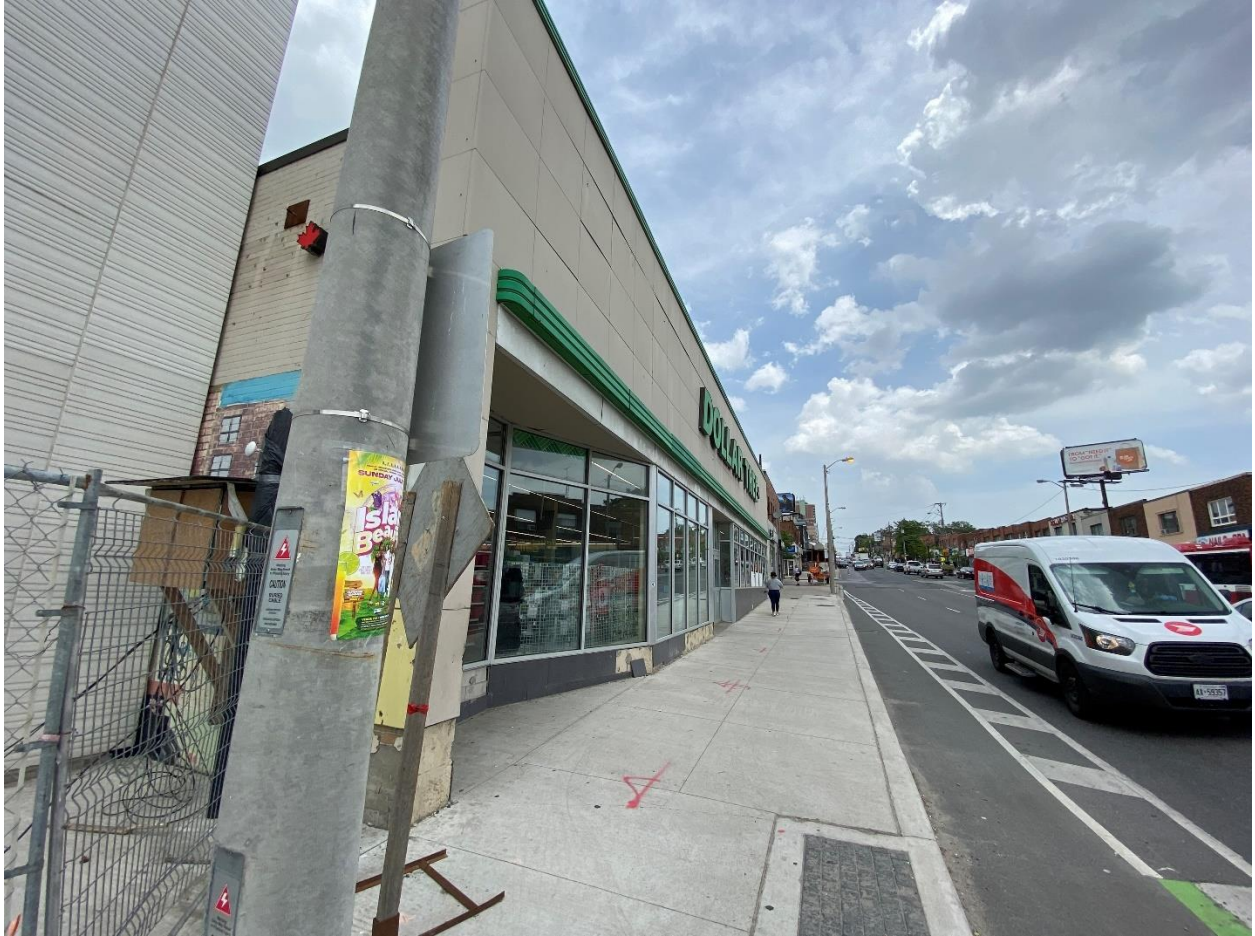
Figure 11. Subject property (facing northeast).
